A TRIDENT SCHOLAR PROJECT REPORT

NO. 410

**Integration of Carbon Fiber Composite Materials into Air-Cooled Reciprocating
Piston Engines for UAV Applications**

Midshipman 1/C Mark E. Trunzo, USN

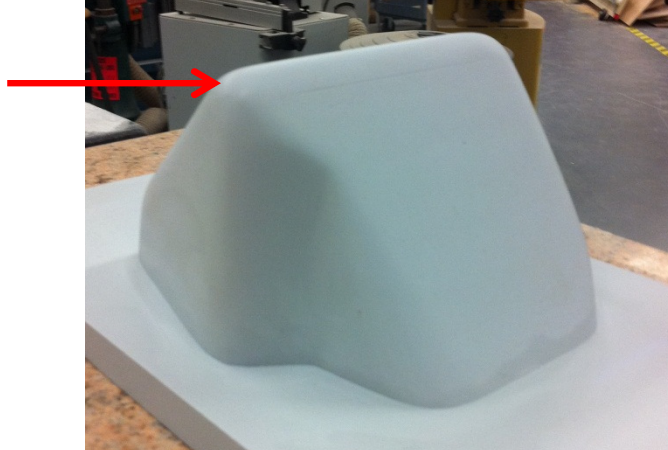
Figure 5: Shaped, Mounted, and Primed Mold for the Crankcase with Weak Spot Annotated

High density foam offered a quick, easy, and reliable way to create a mold for a larger object such as the crankcase. Using aluminum as an alternative would have required significantly more time and effort to create the mold. To achieve the rough shape shown in Figure 4, a foam block was cut using a band saw along one plane of the shape at a time. Then, the mold was sanded down to the exact shape, mounted on a board of PVC, and then primed, as shown in Figure 5. The finished mold is reusable and will allow cured CFRP to reliably release from the mold without sticking.

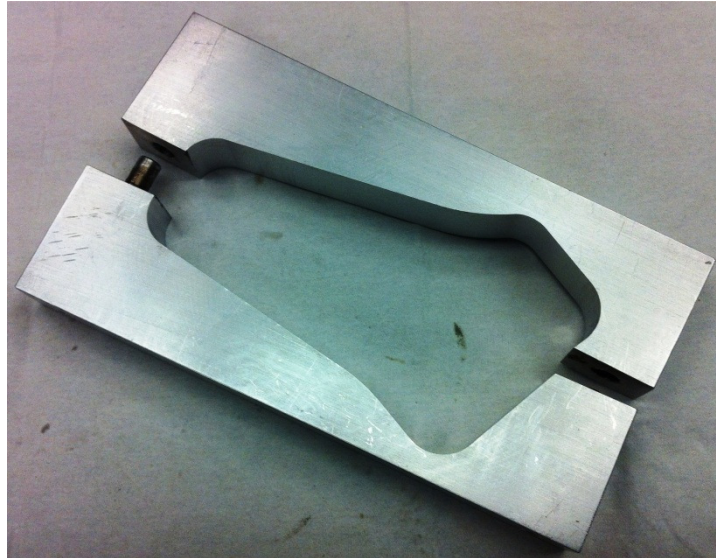
Figure 8: CFRP Connecting Rod Mold

The mold for the connecting rod was made from aluminum due to its smaller size and because the shape was amenable to two-dimensional machining (whereas the crankcase required a three-dimensional mold). In addition, aluminum would maintain its original shape better than a high density foam mold, and would allow more elevated temperatures during the curing process. Since the connecting rod was anticipated to experience potentially higher temperatures, greater cure temperatures were desired. Finally, the crankcase mold proved to need repair after the first crankcase was manufactured, and since multiple connecting rods were desired for testing, the aluminum mold offered the potential for greater resilience. One connecting rod would be tested within the engine and the other two were to be used for crush testing at room temperature and then operating temperature. Figure 8 shows the mold split directly down the middle, off axis from the center line of the connecting rod. For follow on work, this would be advised against due to the sharp curves it leaves when trying to fit the uncured connecting rod in the mold. Instead, it

would have been more advisable to use the center-to-center line from bearing surface to bearing surface as the reference line for cutting.

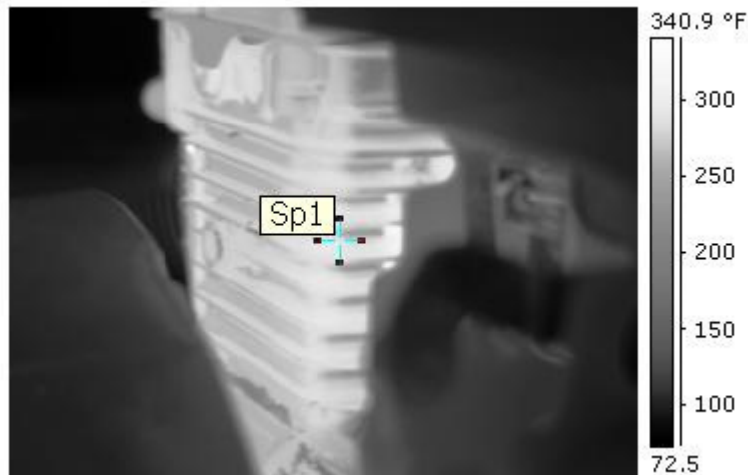
Figure 13: Thermal Imaging Camera Output

Standard surface thermocouples were placed along the side of the crankcase for a temperature profile. A thermal imaging camera and a line of sight thermal gun were also used to measure the temperatures along the side of the crankcase. Figure 13 shows the image produced by the thermal camera during dynamometer testing. The oil was measured using a K-type thermocouple that was placed through the oil cap of the engine.

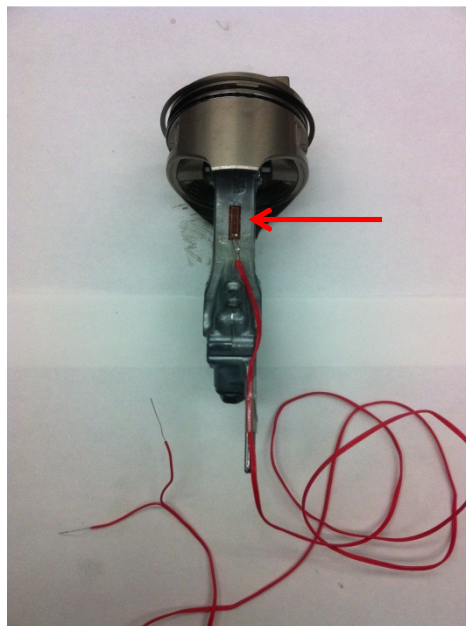
Figure 14: Mounted Strain Gage (Arrow) on the Stock Connecting Rod

Strain measurements were attempted to experimentally measure the strain on stock engine components in order to confirm modeled data and to better design a composite replacement part. In order to obtain the strain during dynamometer testing, an Omega KFG single axis strain gage was fixed at 0° and 90° and mounted below the crankshaft main bushing, as this location was hypothesized to be the location of greatest strain on the crankcase. A strain gage was also mounted on the connecting rod as shown in Figure 14. The wires were epoxied along the inside of the crankcase and run out through the oil drain hole in an attempt to measure strain on the connecting rod during engine operation. While this approach would give an accurate measurement as to what the CFRP design would need to withstand during engine operation, its success depended upon designing a wire path that would withstand the rapid motion of the connecting rod inside the engine, exposed to constant “sloshing” through the elevated oil bath. The strain gages used an Omega BCM-1 full Wheatstone bridge configuration connected to an Omega DMD-465WB high bandwidth instrumentation amplifier with amplification to 2 kHz (-3 dB point). The high bandwidth is unique among strain gage amplifiers, and would allow the dynamic strain signal from engine operation (cycle frequency at 3400 rpm is approximately 30 Hz), but still provide filtering for higher frequency noise created by the spark or surrounding electronic equipment.

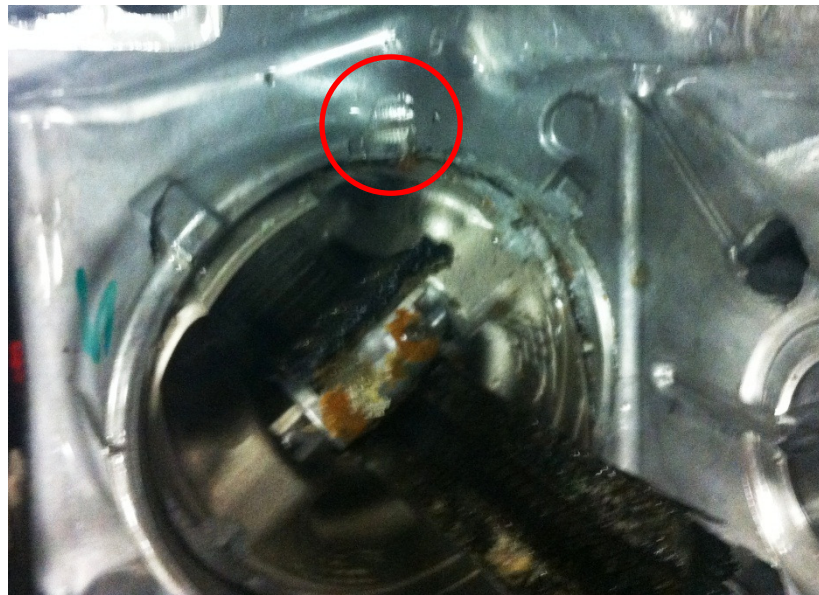
Figure 33 shows what likely caused the ticking sound from within the crankcase. The connecting rod had made contact with the bottom of the cylinder wall, due to being just slightly oversized, creating a small notch in the aluminum. The connecting rod lasted for 130 seconds so the contact was likely not the cause of the failure. In fact, the connecting rod was likely strong enough to actually carve out this notch in the aluminum.

Figure 33: Contact Point of the Connecting Rod and the Cylinder Wall

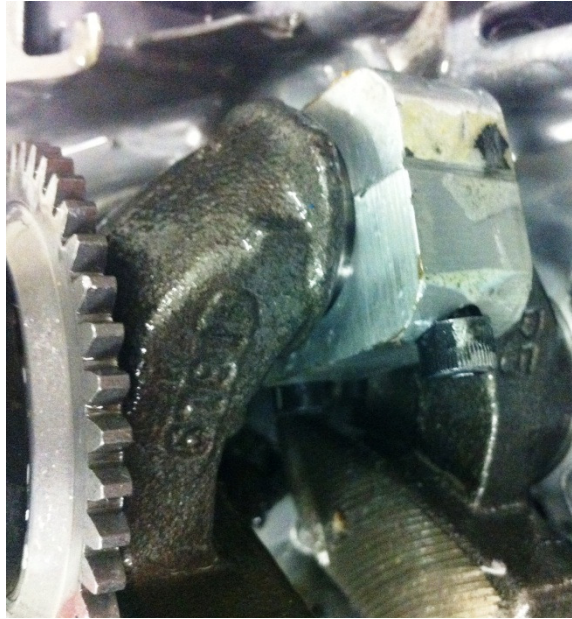
Figure 34: Seized Bearing Surface

The connecting rod pieces were inspected to further investigate the cause of failure. When the crankshaft was rotated, it was noticed that the lower coin used as a bearing surface would not spin freely any longer. The bearing surface had seized on the shaft, shown in Figure 34, and required significantly more effort to remove than it took to install.

The bearing surface seizing is what is believed to be the cause of failure. The momentum of the engine caused the crankshaft to continue to spin while the bearing surface seized, causing the coin to freeze in position. Poor lubrication or thermal expansion may have caused the bearing to seize. The momentum broke the bond between the aluminum coin, the CFRP loop, and the G10 core. Once the aluminum coin was no longer attached, the piston was not able to continue to move up and down the cylinder, leaving the remaining parts of the connecting rod dangled in the path of the spinning crankshaft. This caused more damage and resulted in what looked like the catastrophic failure in Figure 35. The likely cause of this failure was improper sizing of the main connecting rod-to-crankshaft bearing, resulting in limited lubrication. The bearing must maintain an adequate gap to allow an oil film to persist; without this lubrication, excessive friction can cause the joint to stop rotation. This “failure” represents a mundane manufacturing mistake—improper sizing of the bearing. While this is an important lesson learned, the test failed to uncover a failure mode directly associated with the CFRP composite connecting rod, or to uncover the potential viability of the design. Over the course of this 130 second test, the connecting rod likely did not fail due to any failure of the CFRP or integration of CFRP with the G10 and aluminum bearings.

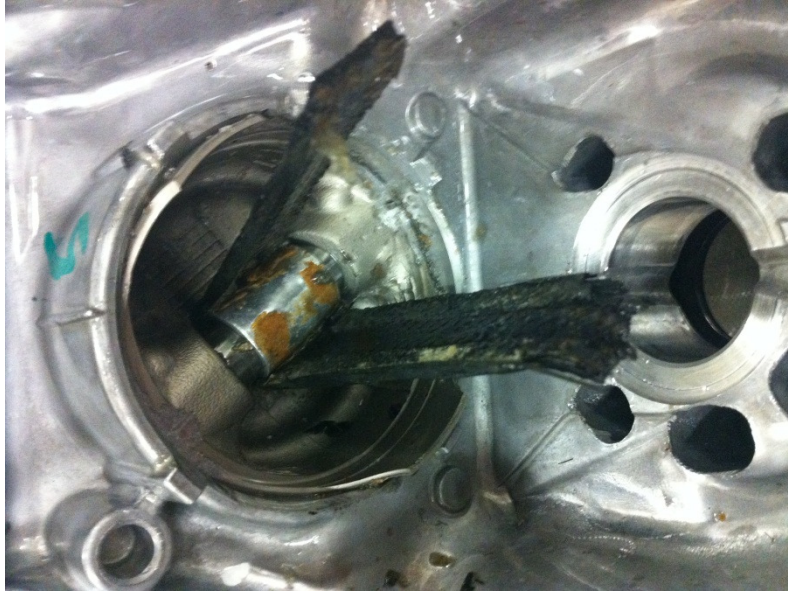
Figure 35: Catastrophic Failure of the CFRP Connecting Rod

Figure 35 shows that the CFRP loop itself did not fail, rather that the parts within the CFRP loop were torn out.

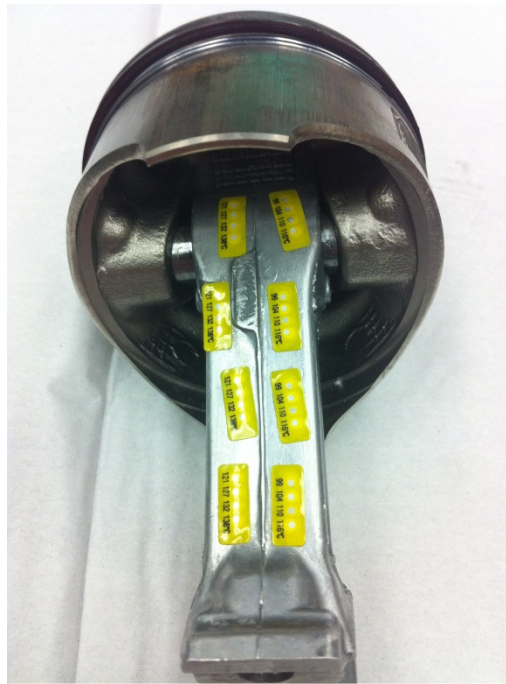
Figure 38: Surface Temperature Indicators along the Length of the Connecting Rod

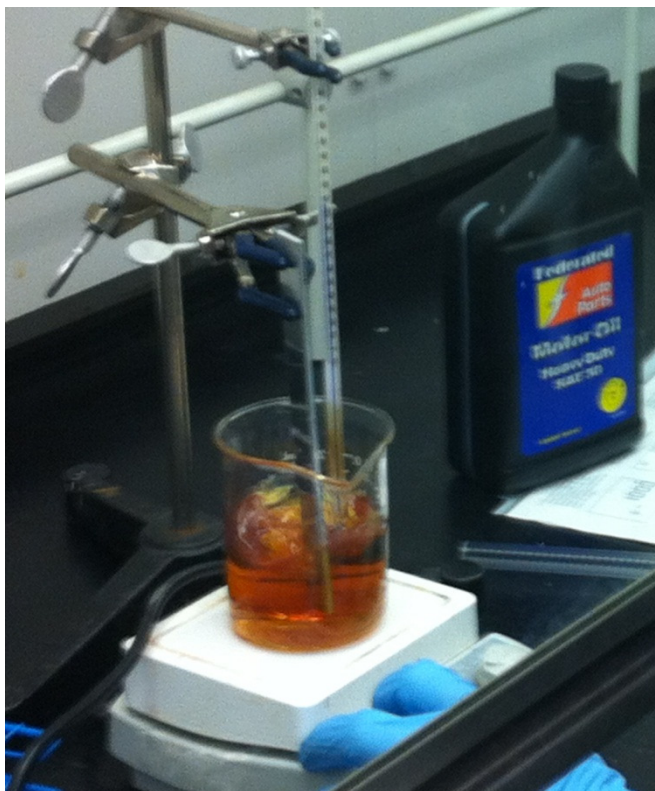
Figure 39: Hot Oil Bath Test Setup

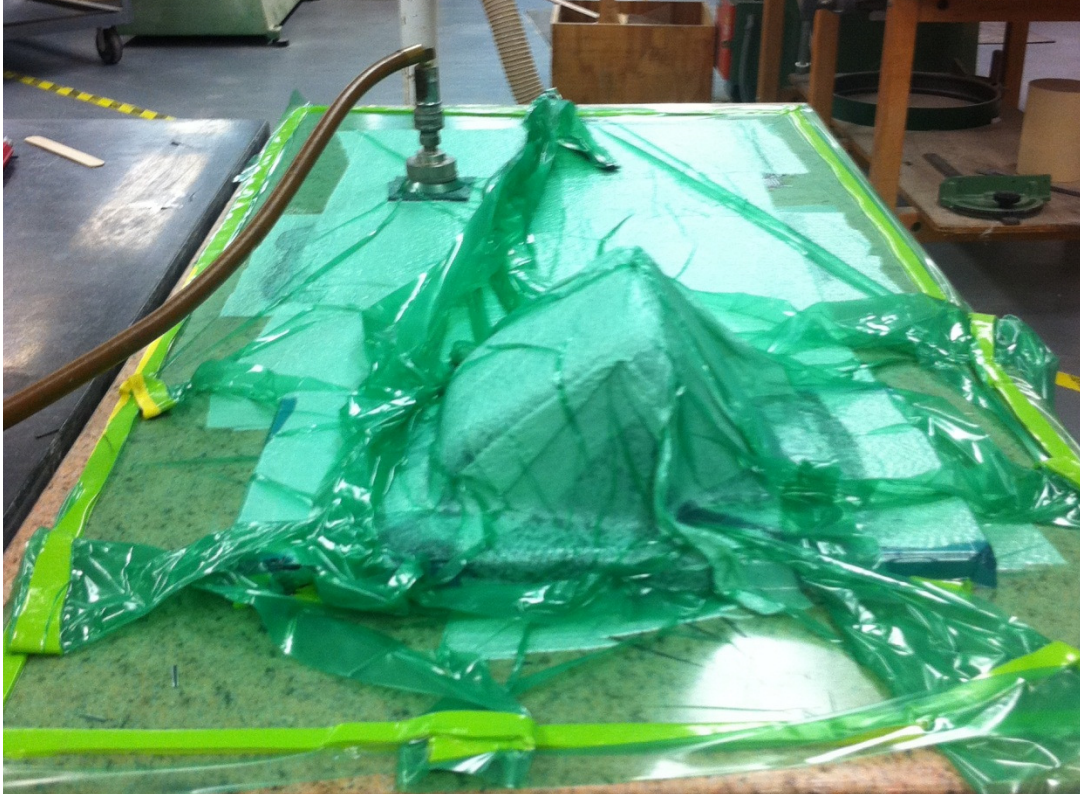
Figure 42: Vacuum Bagging of the Room Temperature Cure Crankcase and Test Panels

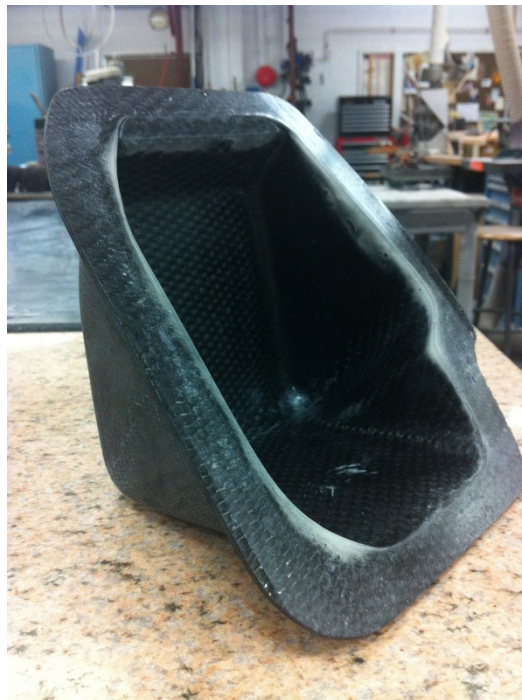
Figure 43: Room Temperature Cure Crankcase

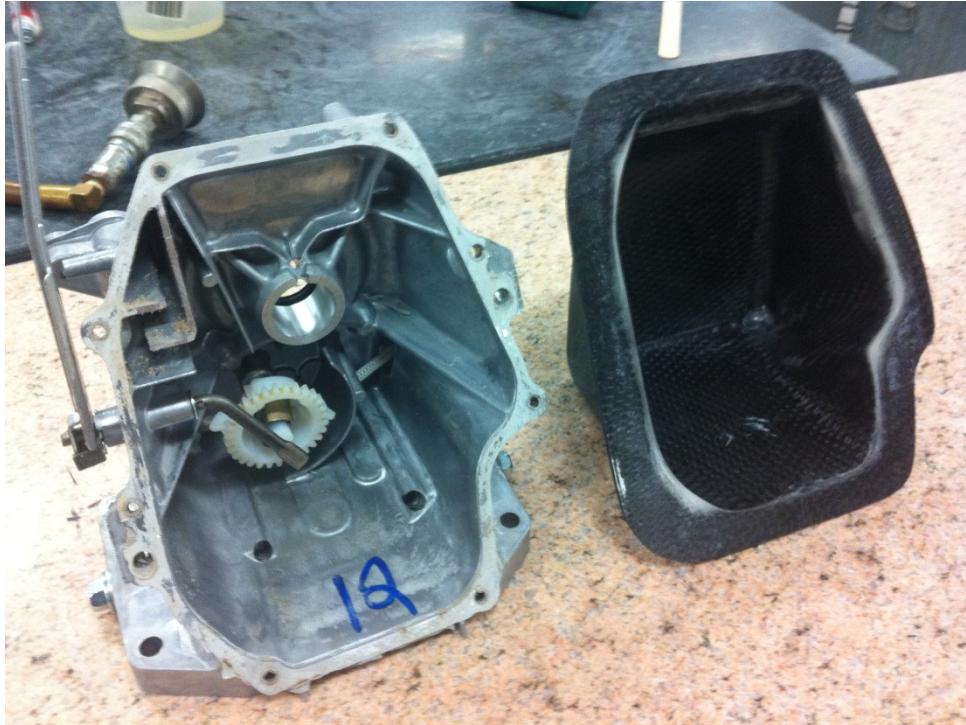
Figure 44: Aluminum Crankcase and CFRP Crankcase Comparison

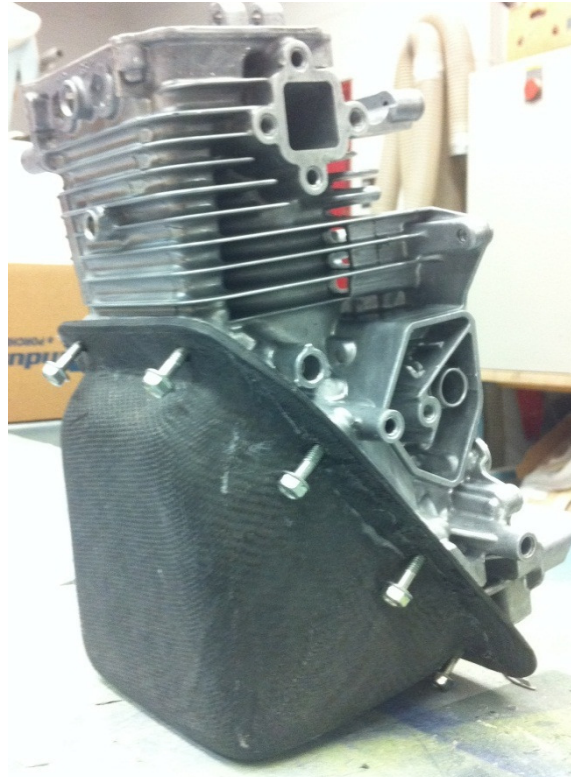
Figure 50: CFRP Crankcase Fitting to Upper Portion of Engine

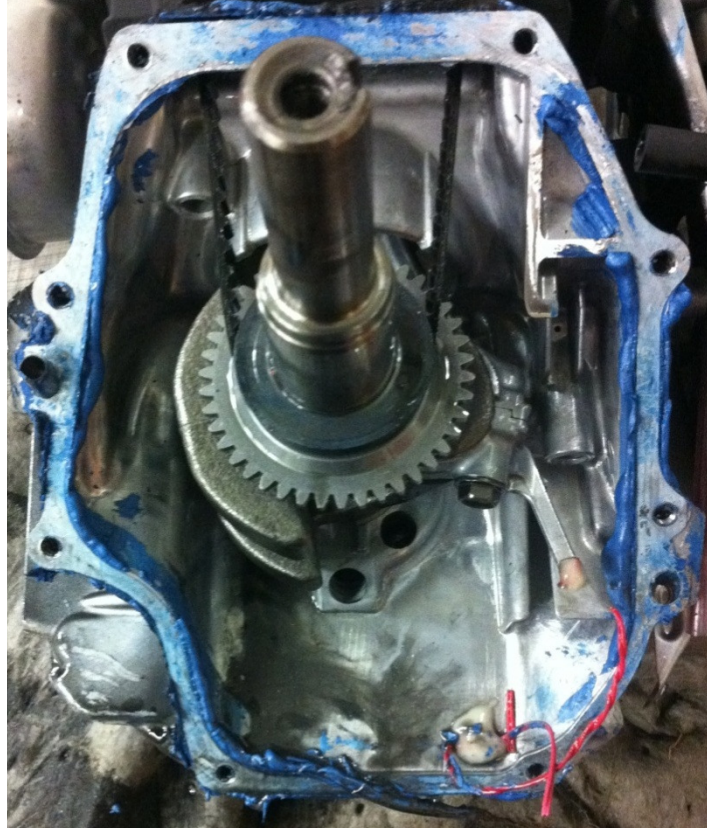
Figure 54: Failed Tests due to Wire Fatigue

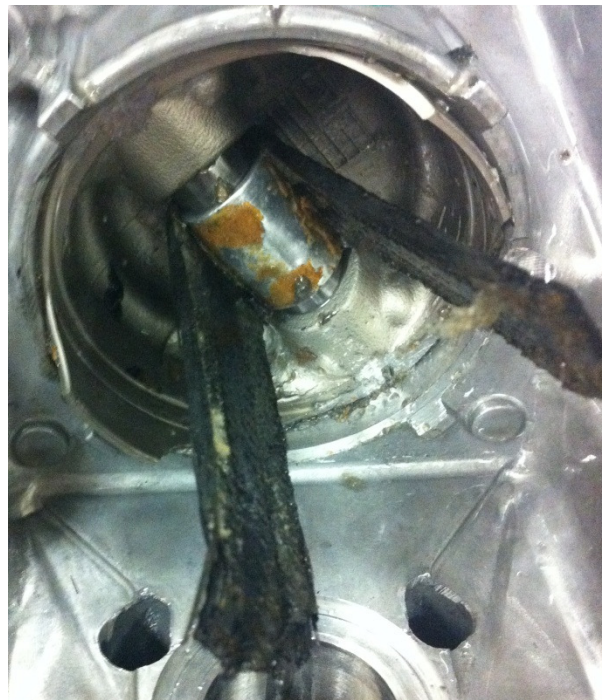
Figure 55: Failed CFRP Connecting Rod due to Bearing Sizing

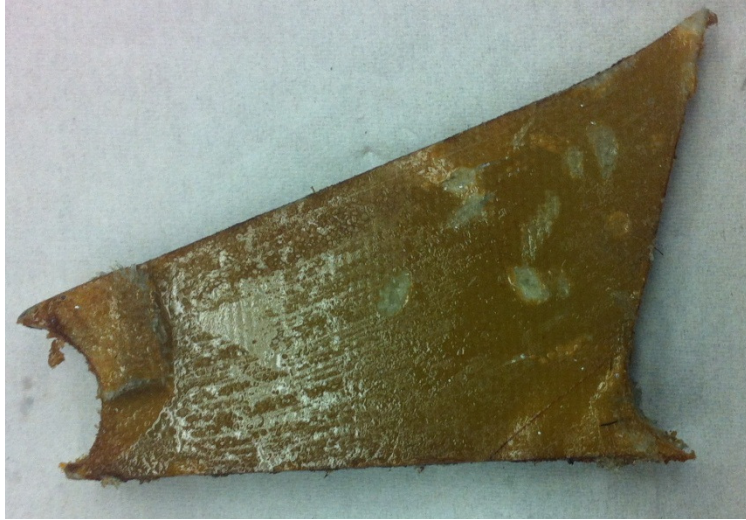
Figure 56: G10 Core after CFRP Connecting Rod Test
